ENERGY SAVER SYSTEM

Distributed by: Insulation
Corporation of America

PRODUCT DESCRIPTION

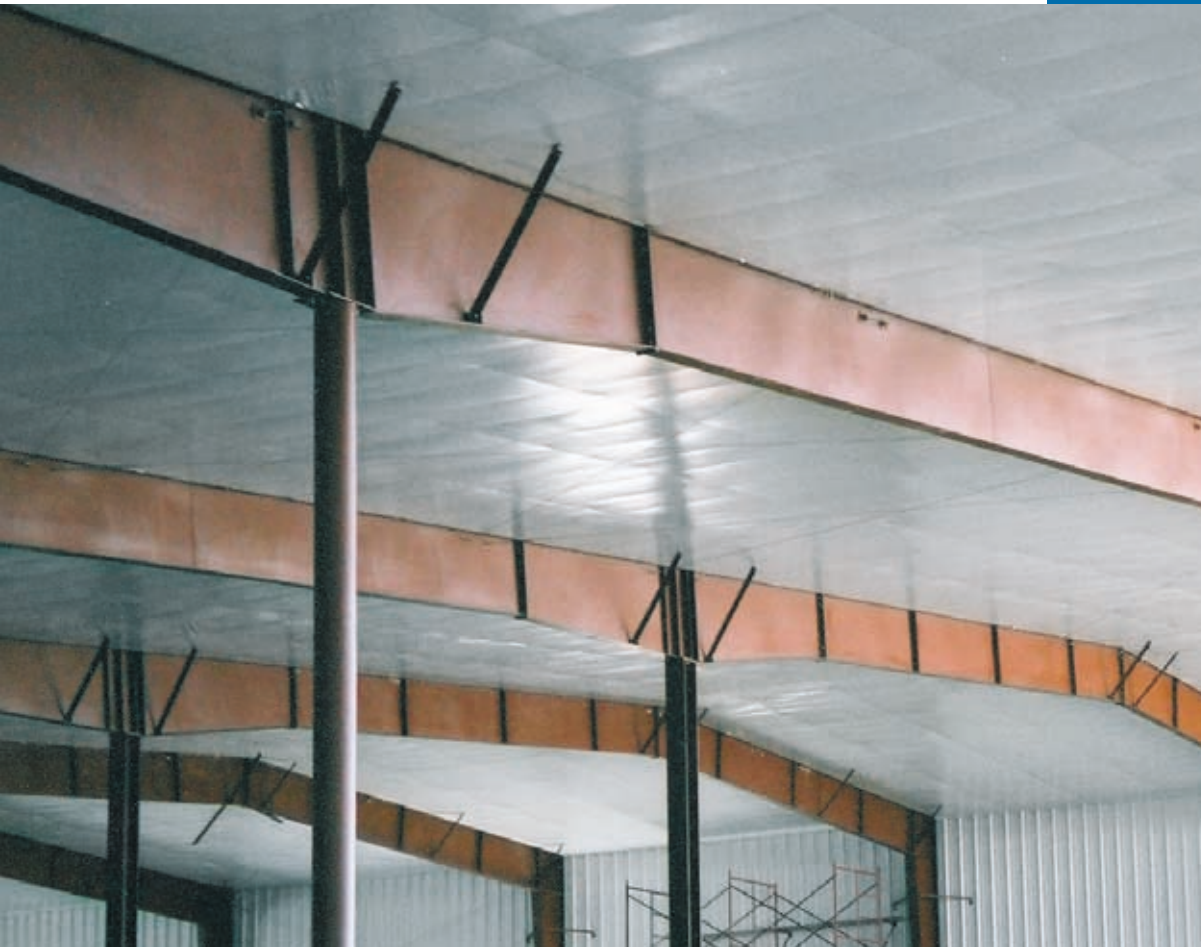
This economical, high R value insulation system consists of a white support fabric, painted steel banding and fiberglass blanket insulation. The fabric is fastened to the inside of the purlins and girts in a metal building and is supported by the banding. The insulation is positioned between the fabric and the roof or wall panels. The R value obtained will vary depending on the physical space available. Most industry experts believe that the space between the fabric and the panels should be filled with insulation in order to avoid potential condensation problems.

Maximum thermal performance is achieved with this system, as all the space within the purlin/girt cavity can be completely filled with insulation. The finish is bright, durable, and requires little maintenance.
